# Manhole Inspection Summary

Manhole # S43SS\_008MH

**Location** Address: **1628 MONTPELIER ST**

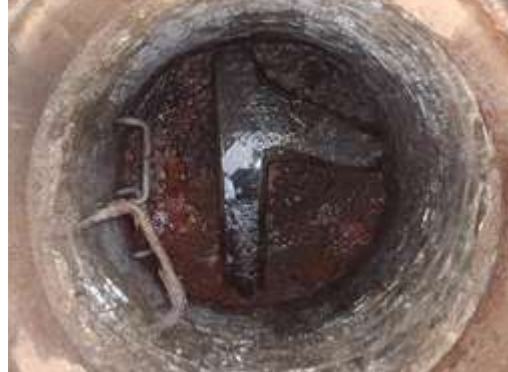
Top View

Barrel infiltration. Corroded steps.  
Evidence of surcharge - Bench debris.  
Channel debris.

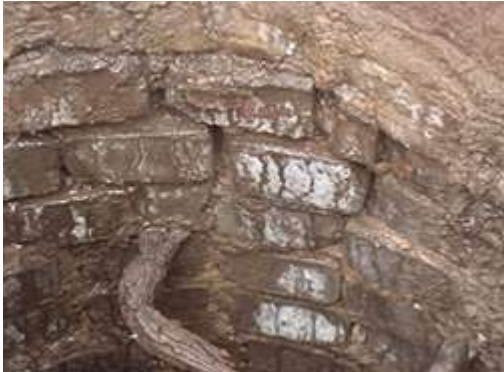
Defect

Adjustment and Corbel deterioration and infiltration.

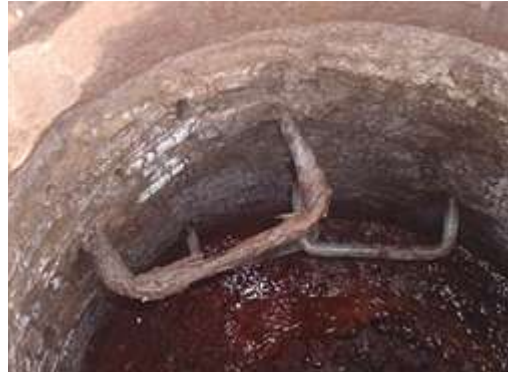
Defect

Frame leaks. Adjustment deterioration and infiltration.

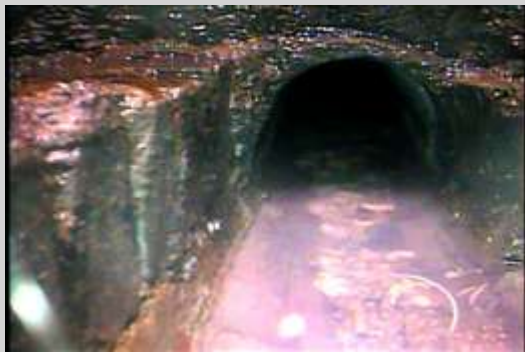
### 8 in. Circular Gravity Sewer Pipe Out @ 12 O'Clock

Channel deterioration.

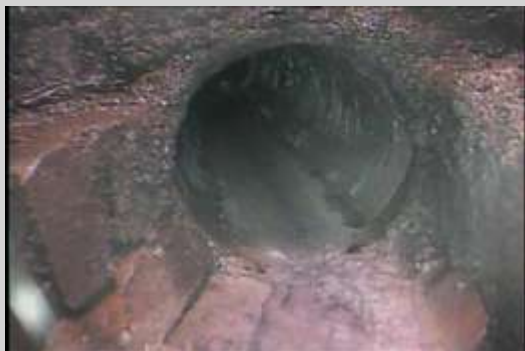
### 8 in. Circular Gravity Sewer Pipe In @ 3 O'Clock

Channel and Bench deterioration.

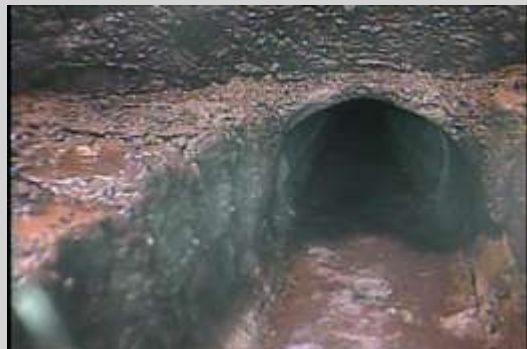
Pipe In @ 6 O'Clock

Deposits: ☐ None ☒ **Mud** ☐ Sludge ☒ **Debris** ☐ Grease

Silt Depth: **0.5** (in.)
